West Lake Landfill Vicinity

**Radiological Survey and Sampling
November 4-6, 2015
Final Report**

Hazardous Waste Program
Federal Facilities Section
March, 2016

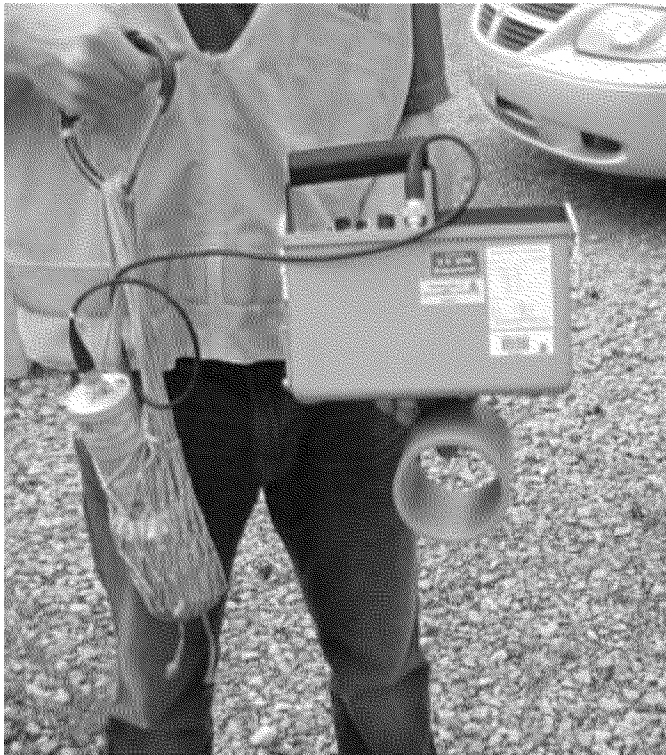
EPA Equipment Y: Ludlum model 2221 with 44-20 NaI Gamma Scintillator detector – This field equipment was brought by and periodically used by EPA personnel at some sampling locations(Photograph 1.)

Photograph 1: EPA Ludlum 2221 with NaI 44-20 detector and directional shield attachment (EPA Equipment Y)

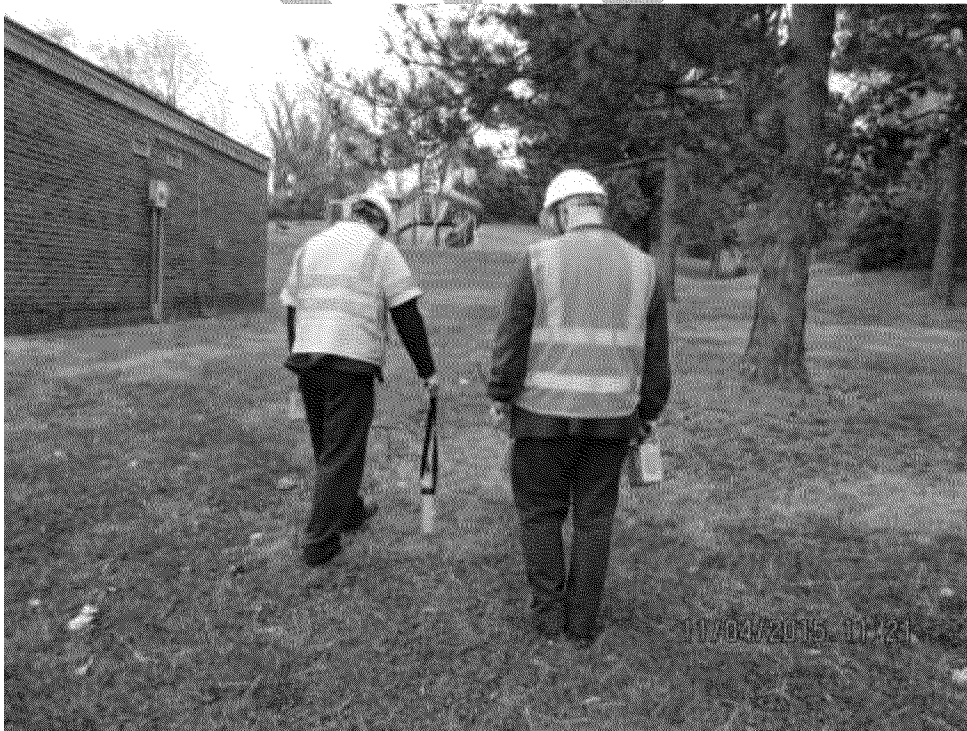
Procedure: For all soil and dust sample locations, equipment B or D was utilized to obtain instantaneous gamma readings where practical at sample areas identified in Figures 1 through 6. Locations within each area identified for soil sampling that had comparatively higher instantaneous readings were flagged for longer scans using equipment B. Some areas were surveyed several times, as shown in Table 4, during this sampling event. Photograph 2 shows an instantaneous gamma survey being conducted at Spanish Village Park.

Photograph 2: Gamma walkover survey conducted at Spanish Village Park

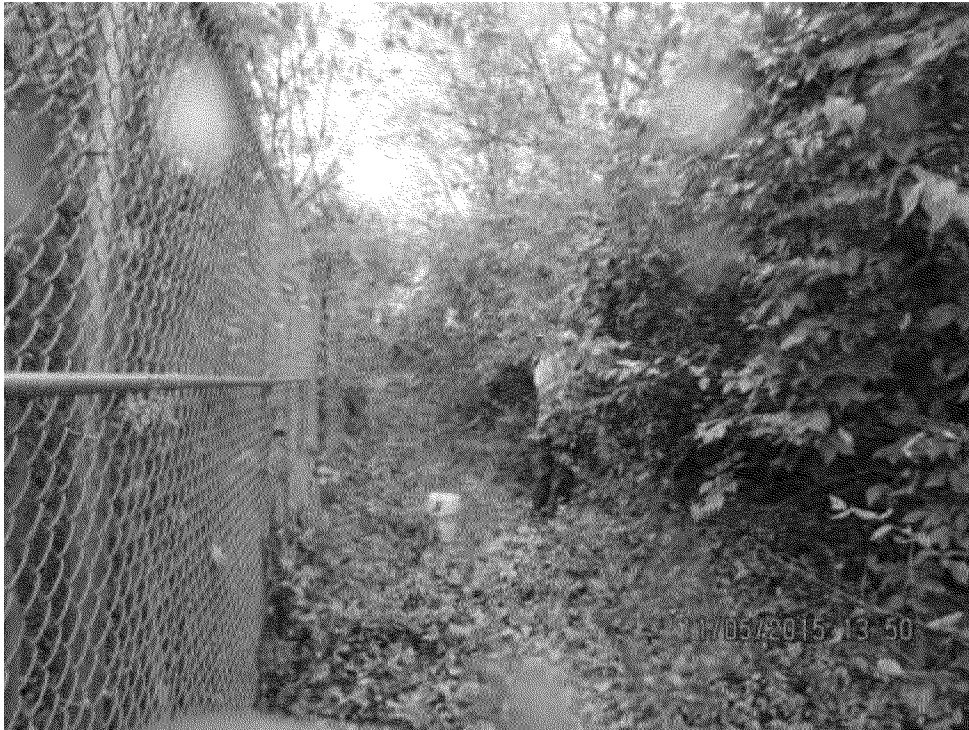
Equipment B: Ludlum model 2221 with 44-10 NaI Gamma Scintillator detector - The meter was utilized to collect instantaneous gamma readings of larger areas (gamma surveys) where practical in order to identify locations with values in the higher range of each area. One-minute readings of each identified location were then collected in order to select each soil and sediment sample location.

Photograph 3: One minute count being conducted on equipment B following gamma survey of immediate area. These locations are flagged in preparation of final soil sample location S09

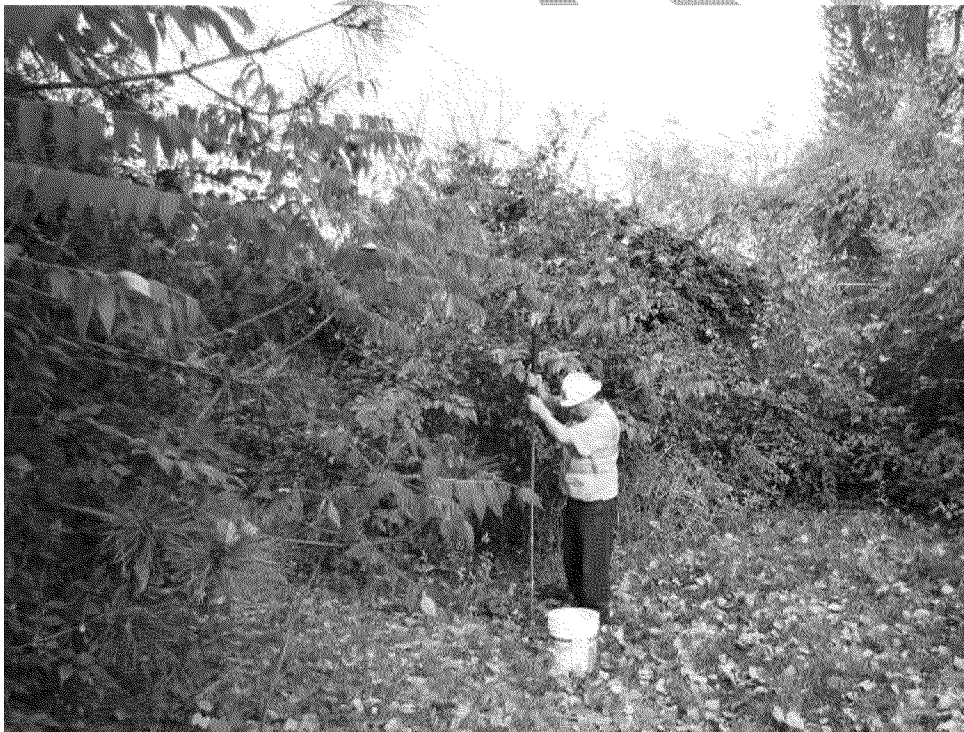
Photograph 4: Soil sampling with Split Spoon sampler

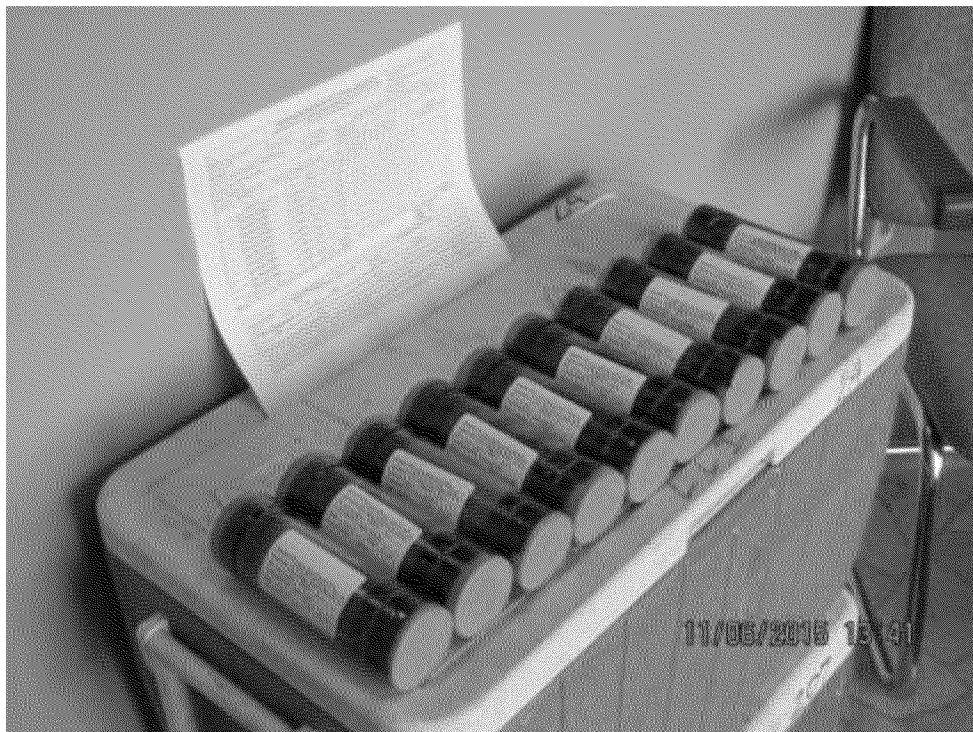
Photograph 5: Soil and sediment samples collected on November 4, 2015 being prepared for shipment

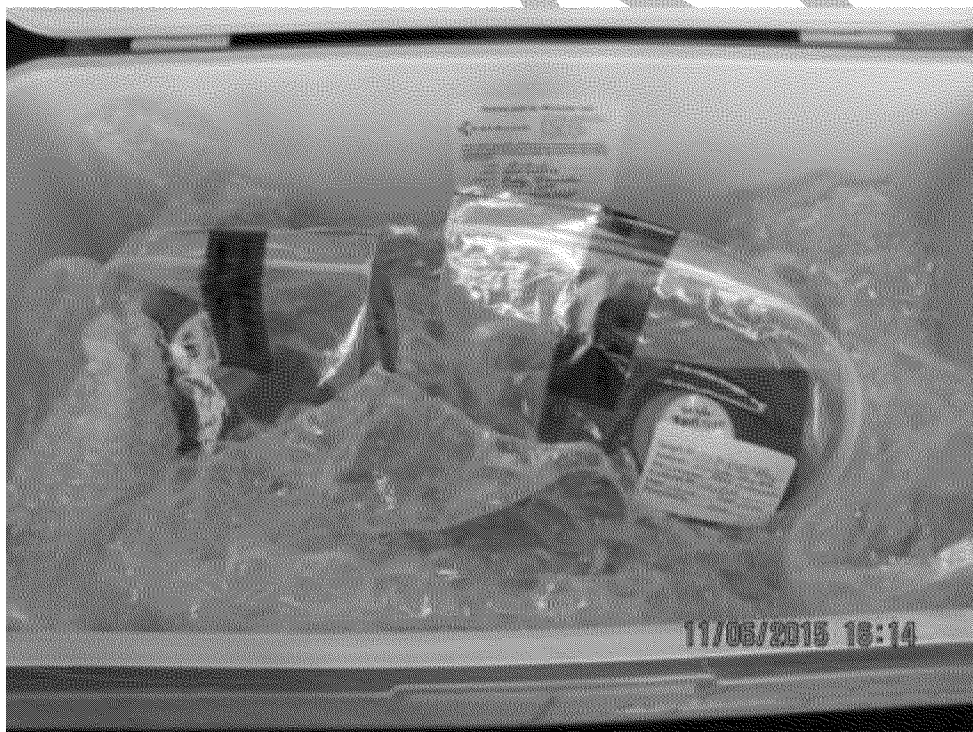
Photograph 6: Surface water samples being prepared for shipment

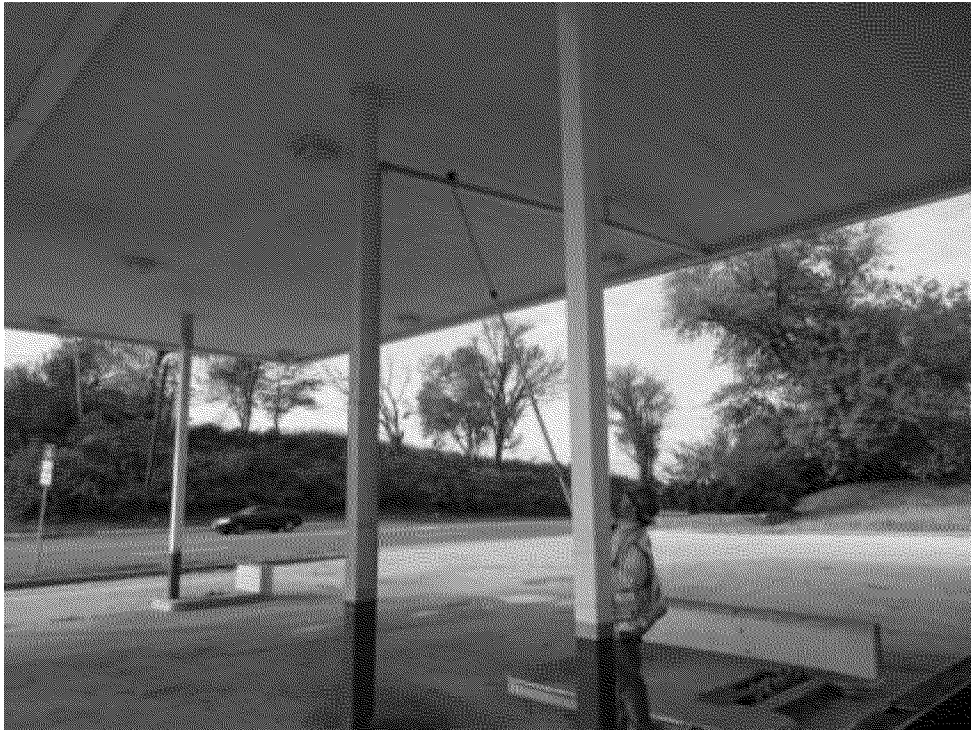
Procedure: Dust swipe samples were obtained at each selected area using dry standard cloth swipes. A preliminary alpha scan of each swipe was performed using Equipment A prior to analyzing the swipe samples on Equipment E for 10-minute count duration alpha and beta - gamma counts. Photographs 7 and 8 show examples of dust sample collection and bench-top tests. Bench-top tests of dust swipe samples were performed first in order to obtain immediate and relatively inexpensive determination of potential presence and activity level of removable radioactive contamination. The results were compared to empty tray counts, and all samples that substantially deviated from empty tray values were flagged for additional analysis. As an additional quality control check, analysis using EPA equipment Z was performed on the flagged samples in addition to an equal number of samples exhibiting typical investigation results. The flagged samples were then sent to Eberline Laboratory for additional analyses. Laboratory results are discussed in Section 4.1.

Photograph 7: Collection of dust swipe sample D02A

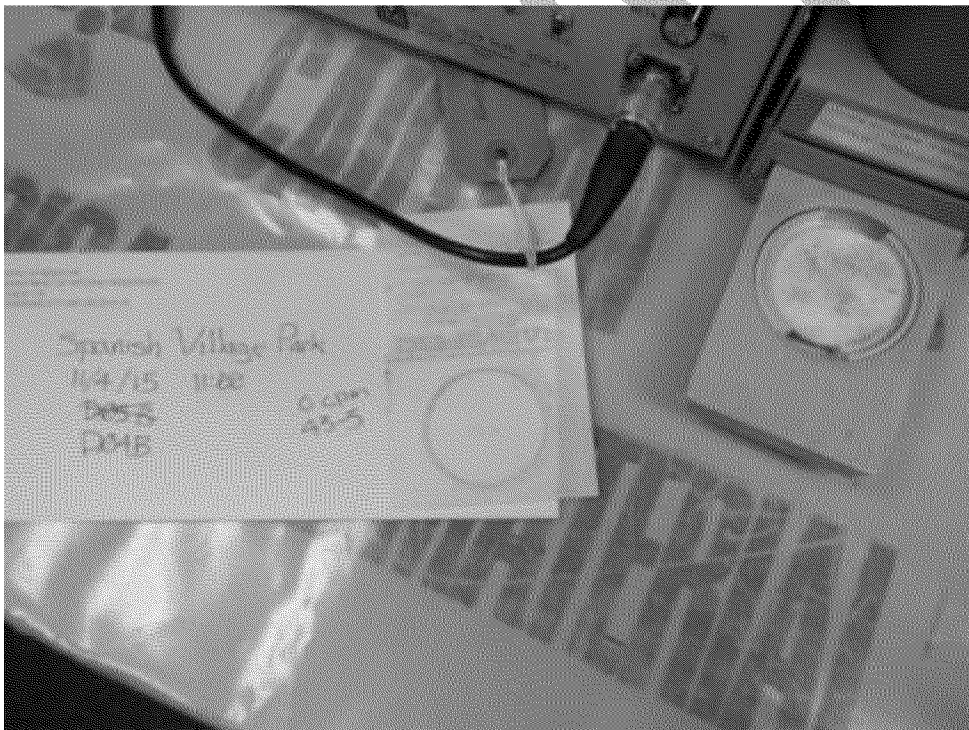
Equipment E: Ludlum model 2929 with 43-10-1 swipe counter - This bench top meter was used to perform alpha counts and combined beta-gamma counts of dust swipe samples. A Thorium 230 check source was periodically used to confirm equipment response.

Photograph 8: Testing of Dust Swipe Sample D04B with Equipment E
